एन एच पी सी लिमिटेड
(भारत सरकार का उद्योग)
NHPC Limited
(A Govt. of India Enterprise)

CORRIGENDUM NO.-1

Name of Work:	Repair along with HP-HVOF coating of Runner (1 Nos.) and Guidevane set (2 sets) for 3X100 MW Francis hydro turbines of Chamera-II Power Station.(E-FILE: 123683)
Tender Specification No.:	NH/CPS-II /Cont./E- 123683/2024-25/20 Date:03.09.2024
Tender ID:	2024_NHPC_824245_1

Report for the assesement of extent of damage on Runner Unit # 3**Photographs: Runner**

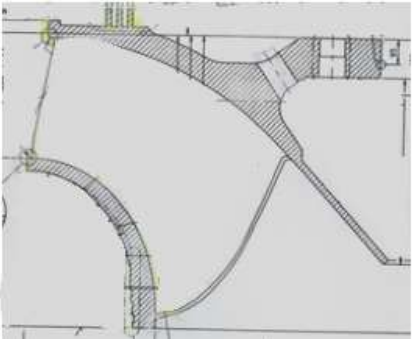
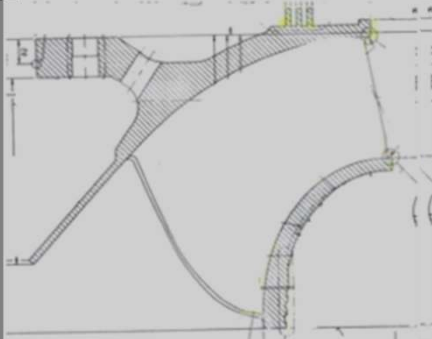
Location	S.No.	Pressure Side				Suction Side			
		Size of erosion mark (sq.mm.)		Area (sq.mm.)	Approx. Depth of erosion mark (mm)	Size of erosion mark (sq.mm.)		Area (sq.mm.)	Approx. Depth of erosion mark (mm)
		Length	Width			Length	Width		
Blade#1

1	800	230	184000	15	240	230	55200	6
	2					450	150	67500	5
Blade#2

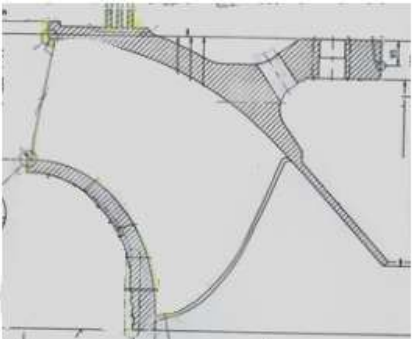
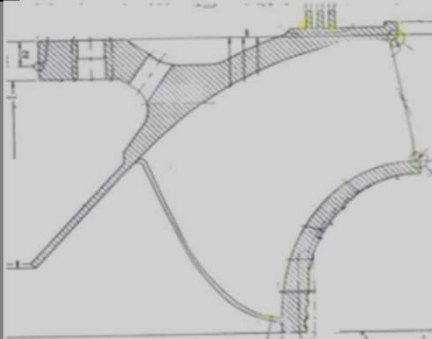
1	700	200	140000	11	300	200	60000	6
	2					500	220	110000	4
Blade#3

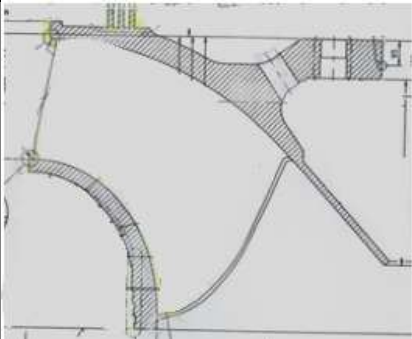
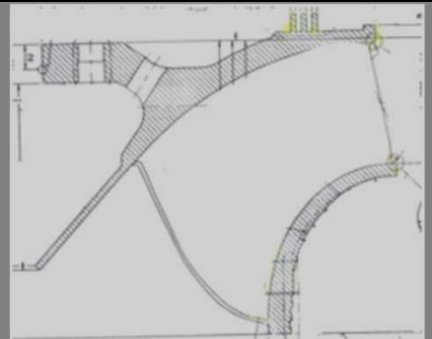
1	600	220	132000	13	300	220	66000	8
	2					420	360	151200	7

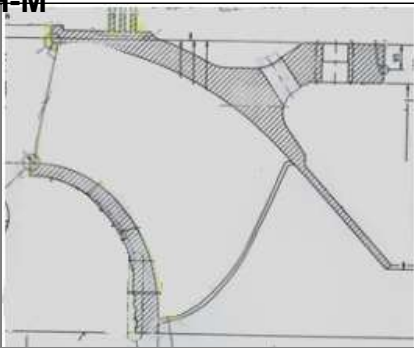
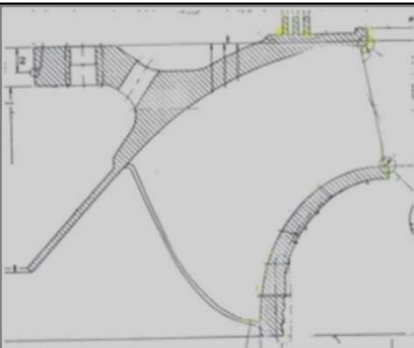
7/2024/O/G HOB PH-M									
Blade#4

1	1000	200	200000	8	320	300	96000	3
	2					440	260	114400	4
Blade#5

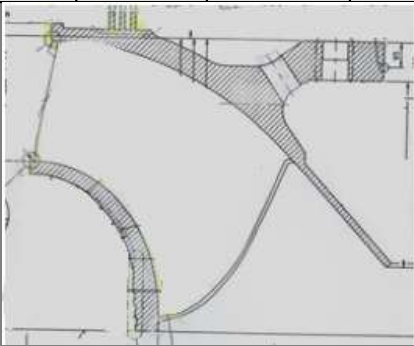
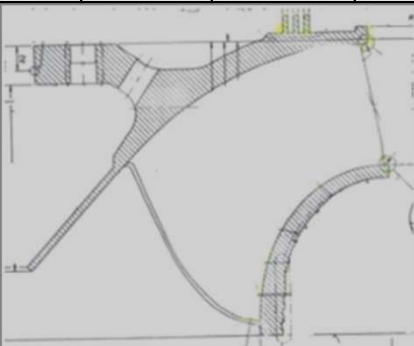
1	850	190	161500	18	360	340	122400	5
	2					420	240	100800	3
Blade#6

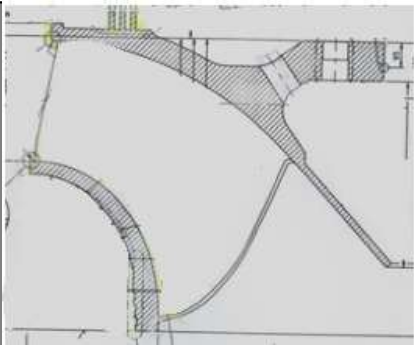
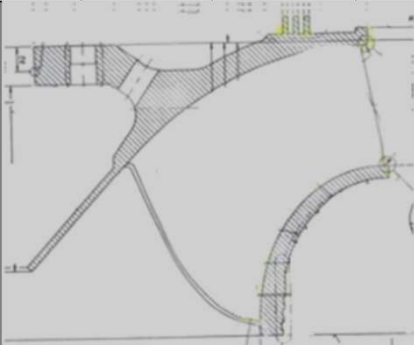
1	1050	200	210000	9	360	270	97200	7
	2					290	240	69600	7
Blade#7

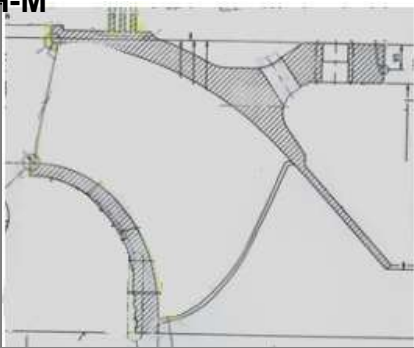
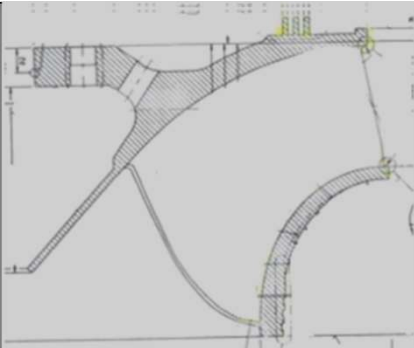
7/2024/O/G HOB PH-M									
Blade#8

1	1100	230	253000	8	270	240	64800	5
	2					345	260	89700	5
Blade#9

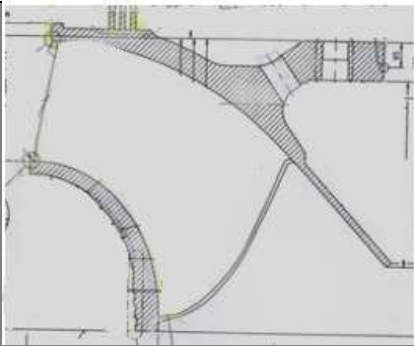
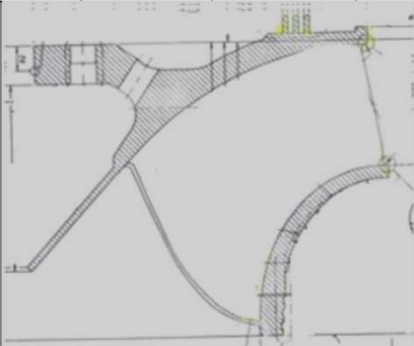
1	900	260	234000	8	240	170	40800	6
	2					420	240	100800	5
Blade#10

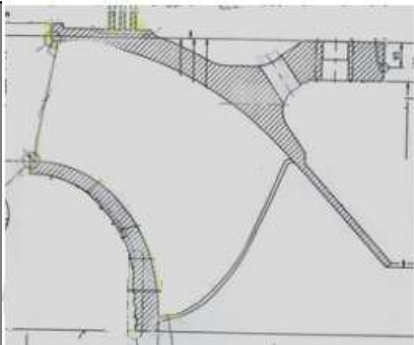
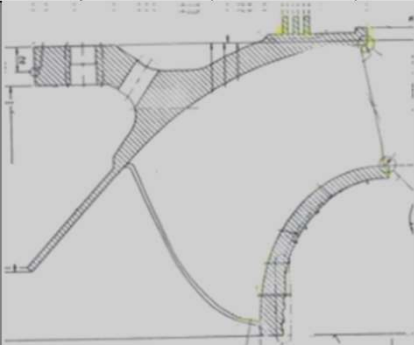
1	800	270	216000	11	380	140	53200	6
	2					300	270	81000	5
Blade#11

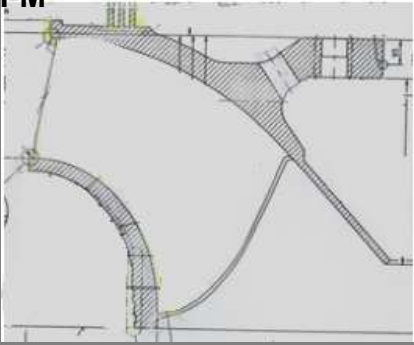
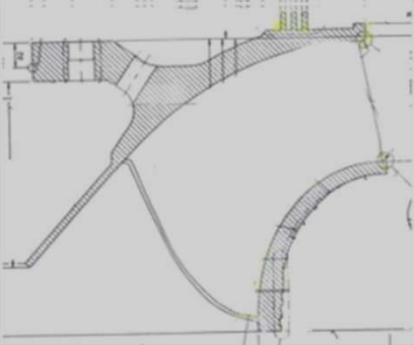
Blade#12

1	1050	250	262500	7	300	120	36000	5
	2					250	100	25000	5
Blade#13

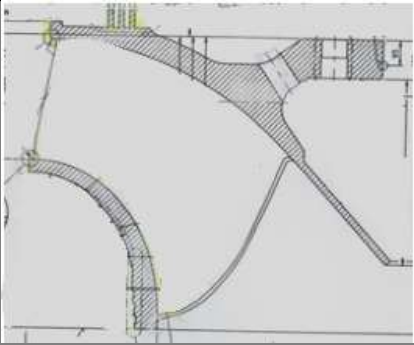
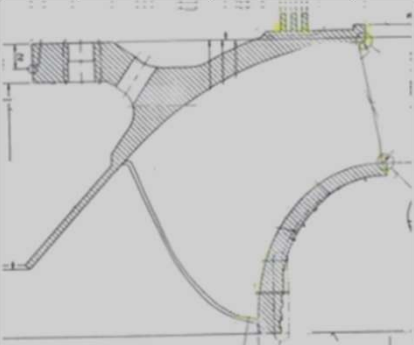
1	750	240	180000	18	280	240	67200	7
	2					330	130	42900	6
Total Surface Area (A1)		2647300		sq.mm.		A2		2039200	sq.mm.

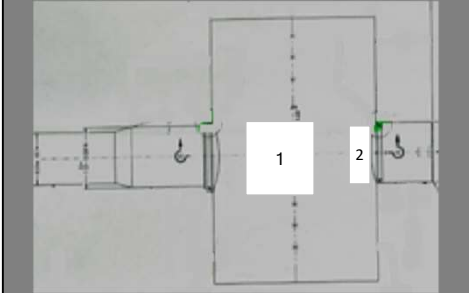
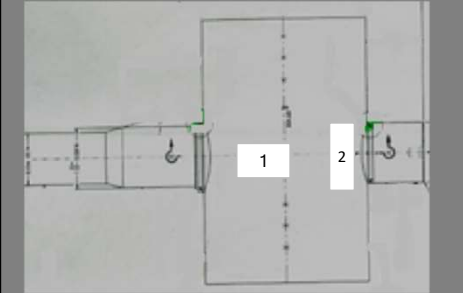
1	460	380	174800	1	120	100	12000	1.5
	2	10	90	900	1.5	20	90	1800	2
GV#4 & 7

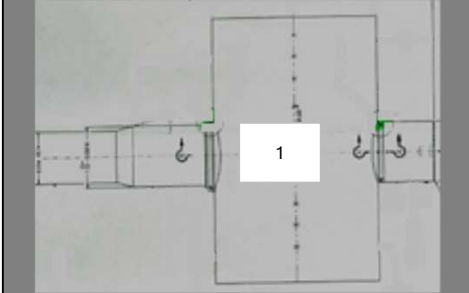
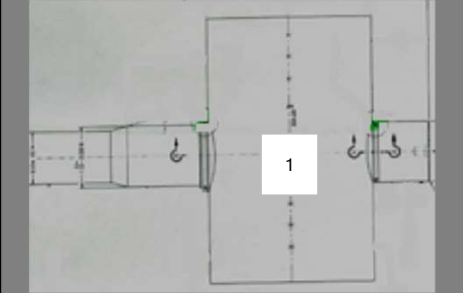
1	175	163	28525	3	260	290	75400	3
GV#8 & 11

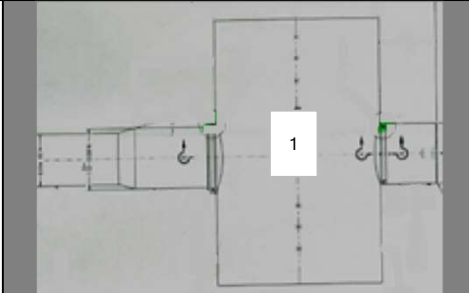
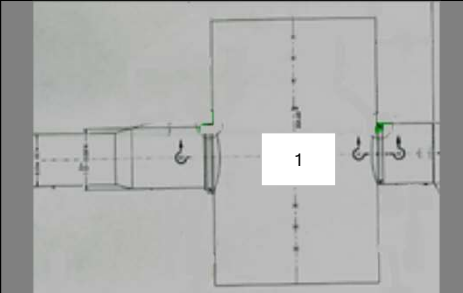
1	45	78	3510	2	160	135	21600	1
GV#12 & 13

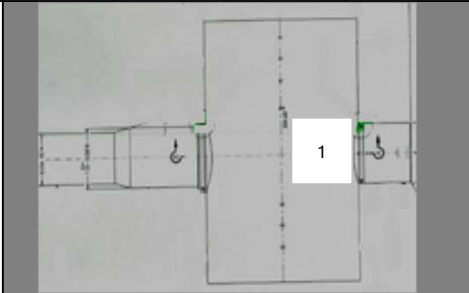
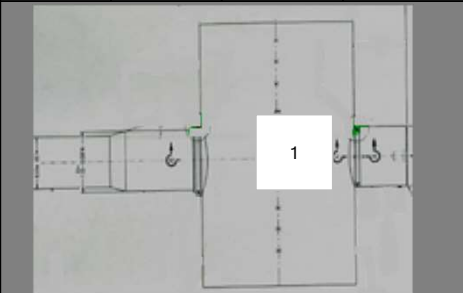
1	170	95	16150	1.5	450	360	162000	3

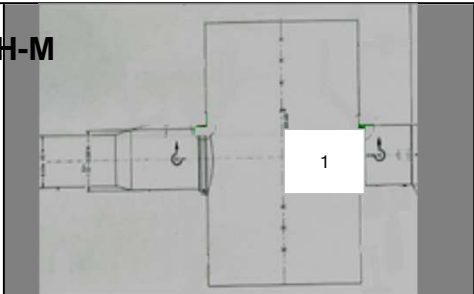
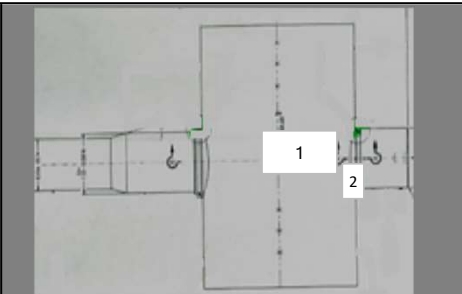
24/O/o HOD-PH-M										
GV#14 & 15

1	465	450	209250	2	460	365	167900	2	
	2					10	25	250	1.5	
GV#16 & 17
